Grant Narrative Information Sheet**1. Applicant Identification:**

Cisco Development Corporation, 701 Conrad Hilton Blvd., Cisco, TX 76437. We are a city entity. We are designated to help improve the economy of Cisco, TX.

Westfall Property, 1101 W. 8th St & 804 Ave N, Cisco, TX 76437

Aptim Environmental and Infrastructure, Inc. (APTIM) is submitting this Analysis of Brownfields Cleanup Alternatives (ABCA) for the remediation of asbestos-containing material (ACM) and lead-based paint (LBP) found in the interior and exterior of the buildings at the above-referenced site.

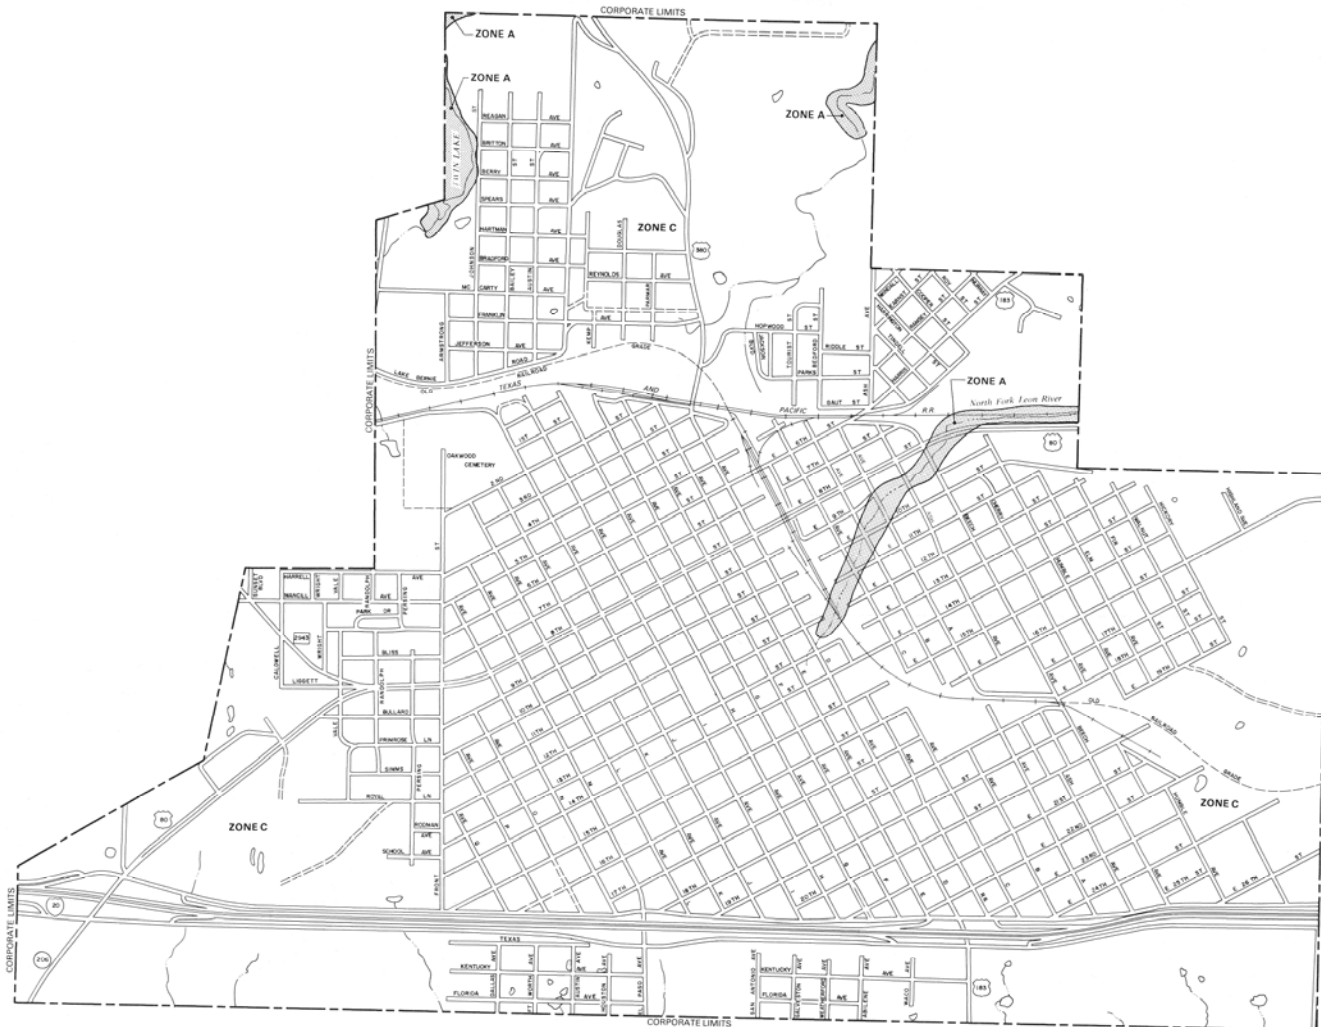
Attachment B
FEMA FIRM

ZONE	EXPLANATION
A	Area of 100-year flood; base flood elevations and flood hazard factors not determined.
AE	Area of 100-year shallow flooding where depths are between one (1) and three (3) feet; average depths of inundation are shown, but no flood hazard factors are determined.
AH	Area of 100-year shallow flooding where depths are between one (1) and three (3) feet; base flood elevations are shown, but no flood hazard factors are determined.
A1-A30	Area of 100-year flood; base flood elevations and flood hazard factors determined.
A99	Area of 100-year flood to be protected by flood protection system under construction; base flood elevations and flood hazard factors not determined.
B	Area between limits of the 100-year flood and 500-year flood or certain area subject to 100-year flooding with average depths less than one (1) foot or where the contributing drainage area is less than one square mile; or area protected by levees from the base flood. (Medium shading)

C	Area of minimal flooding. (No shading)
D	Area of undeveloped, but possible, flood hazards.
V	Area of 100-year coastal flood with velocity (wave action); base flood elevations and flood hazard factors not determined.
V1-V30	Area of 100-year coastal flood with velocity (wave action); base flood elevations and flood hazard factors determined.
